## Report of an Operational Oil Spill Response Exercise between Finland and Estonia

Name of the exercise:	KOTKA 2013
Place of the exercise:	Outside Kotka, Finland
Date of the exercise:	August 26-28 <sup>th</sup> 2013
Host state of the exercise:	Finland

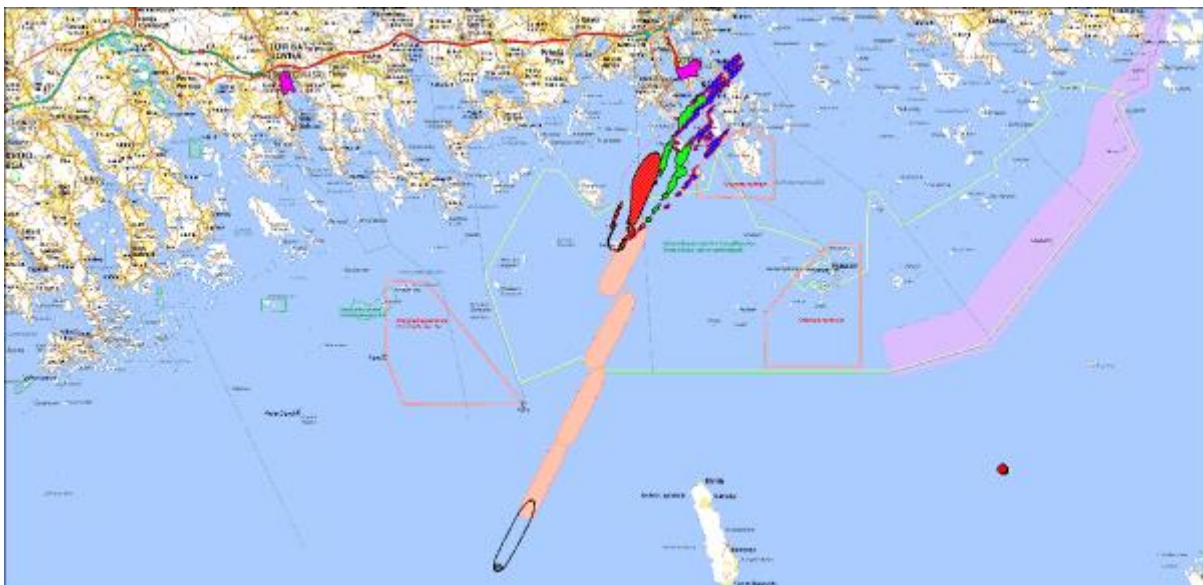
*Map of the drifting scenario. The map shows the calculated slick positions in 6 hour time steps. The red area in the map shows the slick position at the start of the exercise, green and blue areas indicate the slick drift during the exercise.*

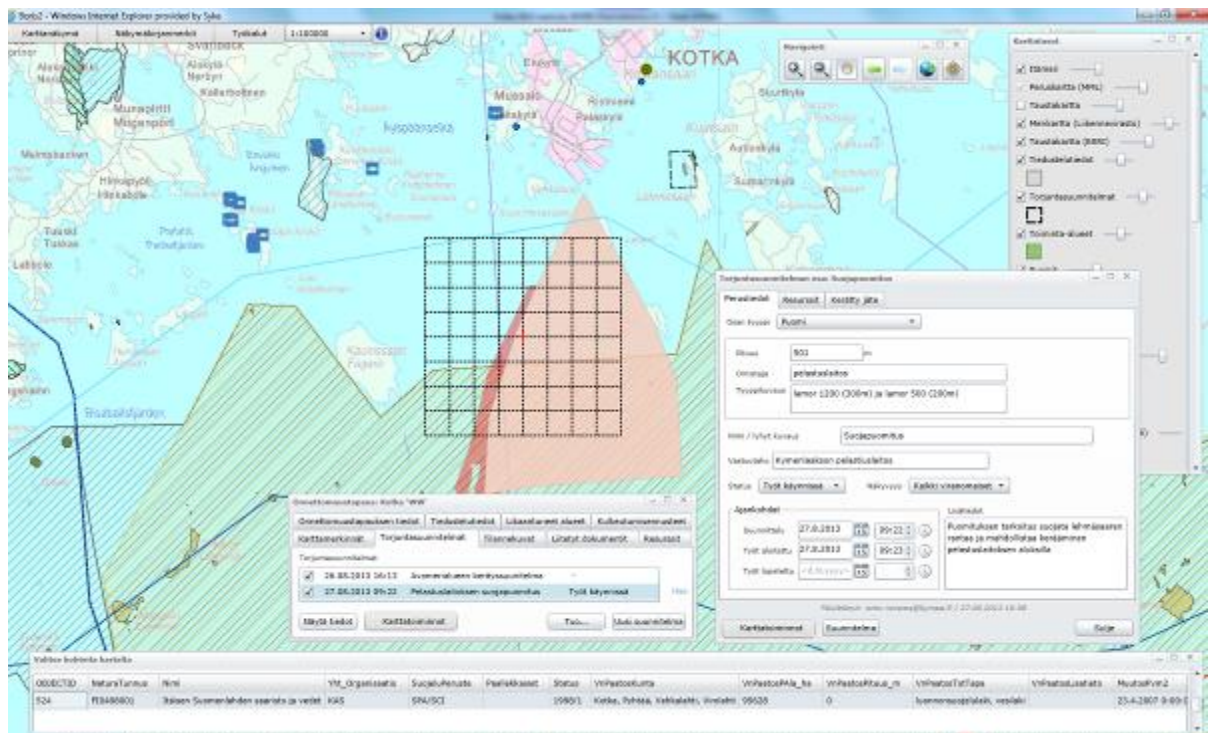
About the same time there were in BORIS information available on action plans of the Kymenlaakso Rescue Services. They were intending to protect north shore of "Lehmäsaari" island and recover oil from sea by boats. That as well as areas to be protected (such as natural resources and recreational areas) were inputted to BORIS :

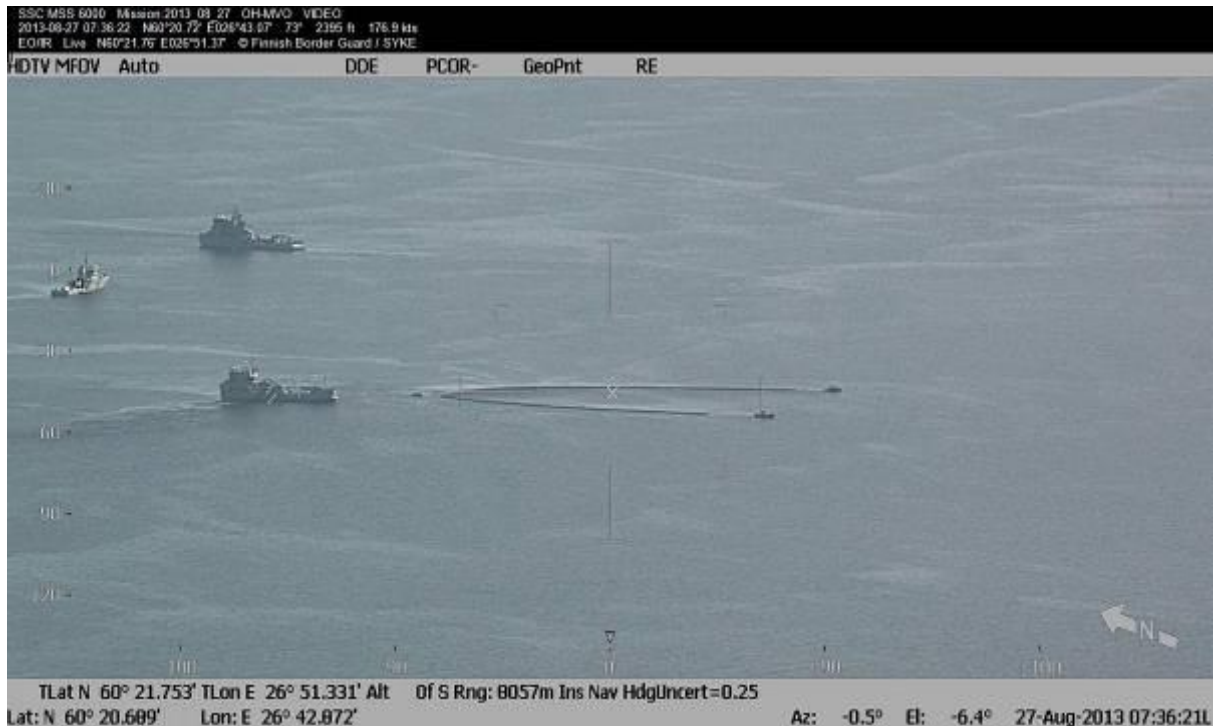
The Teams of vessels acted in their response areas in oil recovery during oil drifting towards islands in east. HYLJE was rigging 1000 meters high sea booms out with two tugs. Other two tugs were towing an oil trawl of 400 meters high sea booms with an opening at the end of it (at the start of the exercise the U-shape boom had no opening in it, but it was done by HALLI crew by emptying 4 air chambers of the boom. HALLI was following the trawl with its sweeping equipment deployed. See the following picture taken by the surveillance plane:

Deploying one kilometre high sea boom out from HYLJE took so much time that she had to start to take it back almost immediately after finishing the deployment. Due to this SOSOC ordered OILI I to join the strike team of SEILI and MERIKARHU.

Recovery vessel HYLJE was bound all time with deploying one kilometre long high sea boom. That was because of last minute cancellation of an ordinary vessel that was planned to be used as boom layer. However it high-lighted, how time consuming high sea boom laying from vessels is.

In real situation recovery vessels shall not be used for boom laying even though many recovery vessels are suitable for boom laying and protective booming is urgently needed. Recovery vessels' ability to recover oil shall be utilized entirely for that purpose and other non-specialized vessels shall be used for booming. High sea booms are irreplaceable in stopping, containing, slowing or steering oil slicks, thus much effort should be put to develop the mobilization of high sea booms. One way is deploying booms from shore to sea and to tow them by tugs to the area - like it was in this exercise for the booms used for the oil trawl.

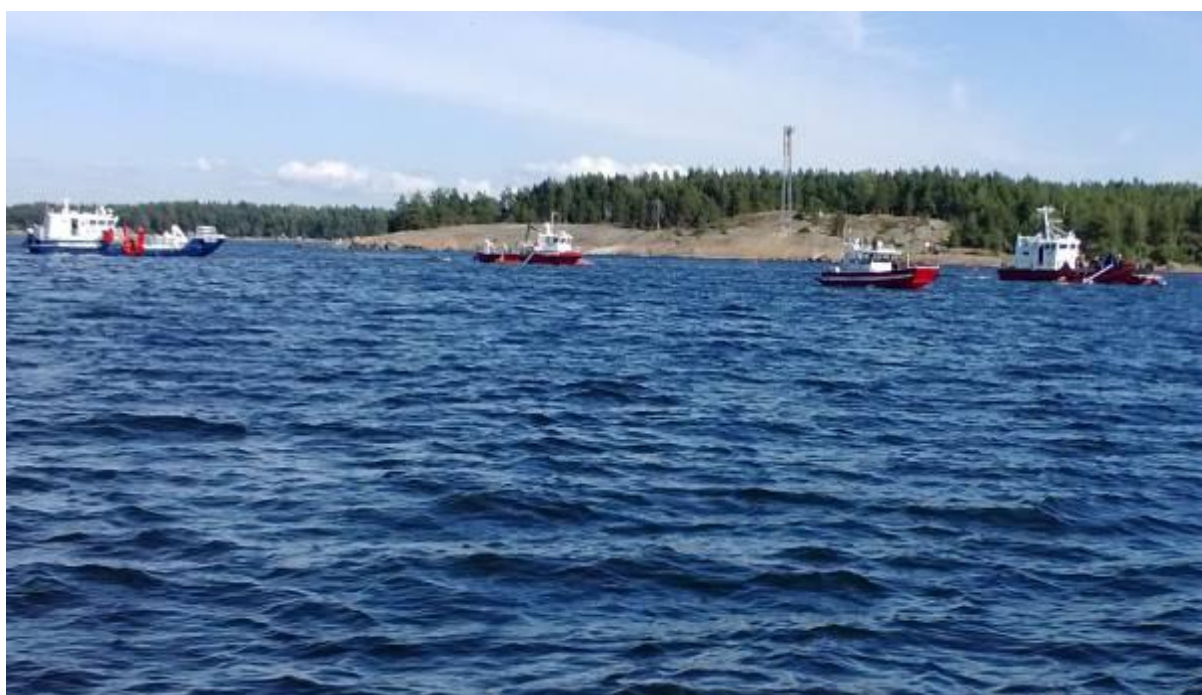
The boats of Kymenlaakso rescue services restricted spreading of oil with booms anchored to shoreline of the island "Lehmäsaari". See the following picture:

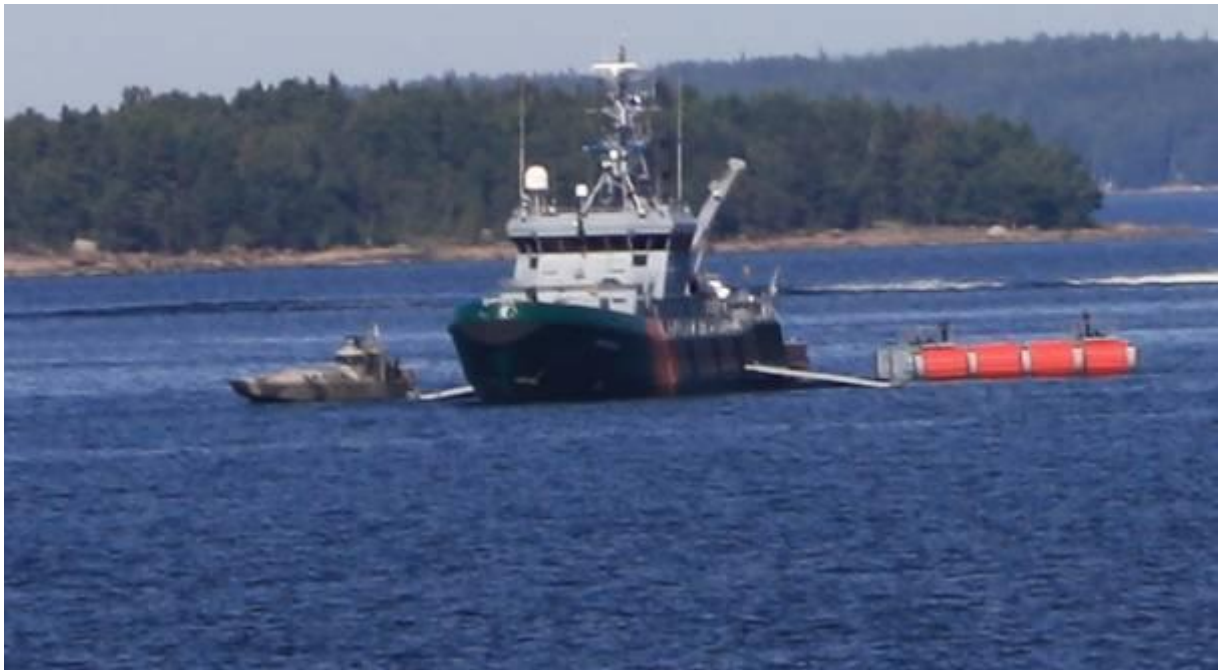
In order to remove recovered oil from vessels with small oil tank capacity there was a floating tank unit "Valas" (volume 200 cubic meters) that was towed by a boat. In the following picture that red tank is beside MERIKARHU.

*MERIKARHU tested the towable tank "VALAS" which the crew felt would enhance usability of MERIKARHU in real cases since her tank capacity is only 40m<sup>3</sup>. One HELCOM grid cell as operating area for three vessels is too small. In all they said it was the most smoothly going exercise they have experienced so far. The equipment worked well and they got new tasks during the course of the exercise.*

*Because of technical problems of the boat that was towing the "VALAS" tank, the VALAS was not available from noon onwards.*

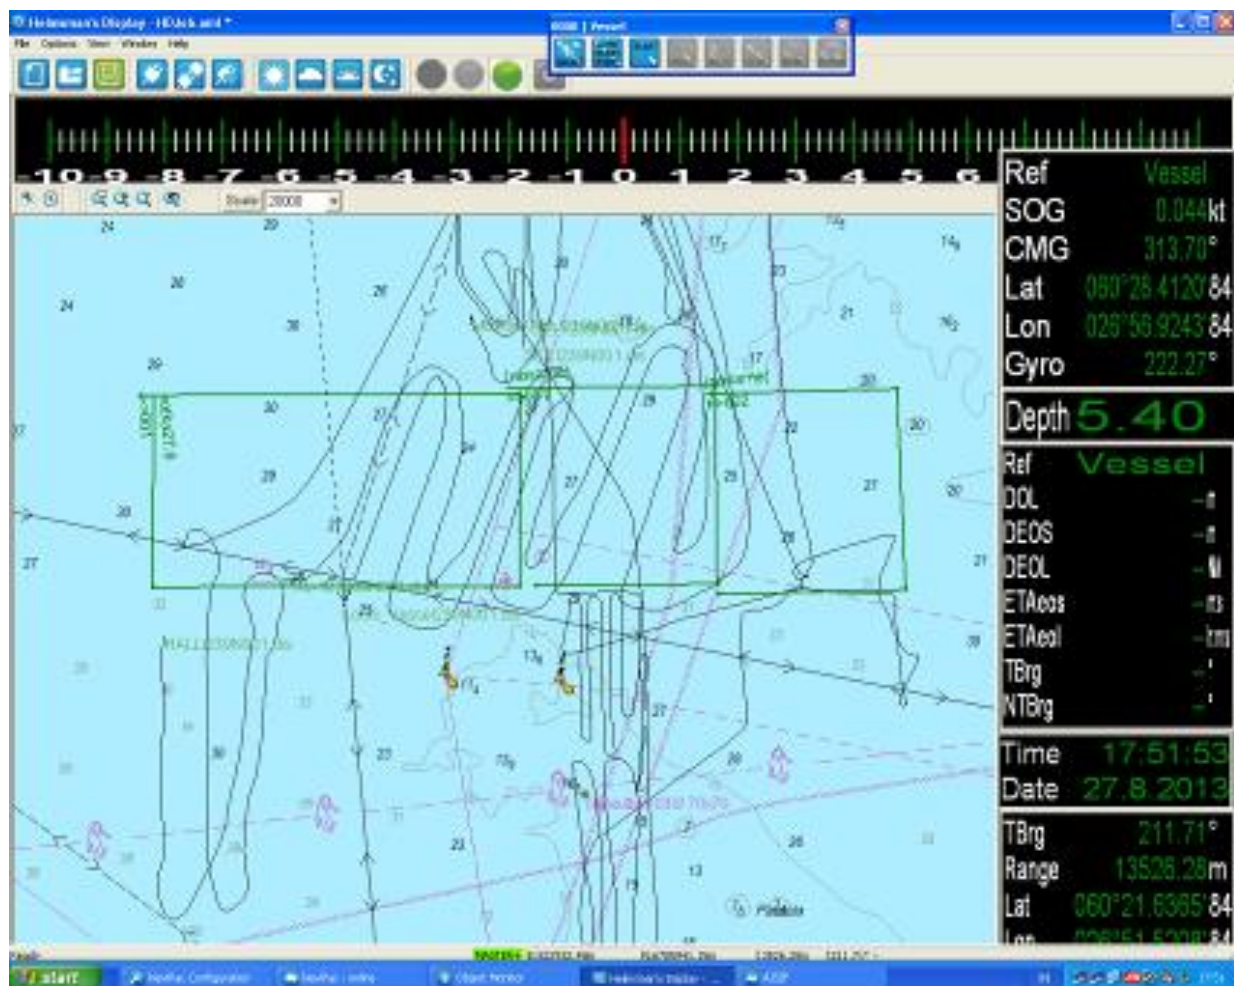
Recovery vessels' movements during the operation were tracked by oil recovery software on board LOUHI. As seen in the picture below the sweeps of the vessels covered the intended areas very well:
